**CAPITAL IMPROVEMENT PROGRAM**  
**City of Missoula CIP Project Request Form FY 2010-2014**

<b>Program Category:</b>	<b>Project Title:</b>			<b>08 Project #</b>	<b>09 Project #</b>	<b>10 Project #</b>
Community Service	Grant Creek Drainage Improvements			CS-12	CS-17	CS-08

RE: Grant Creek Between I-90 and Prospect Drive

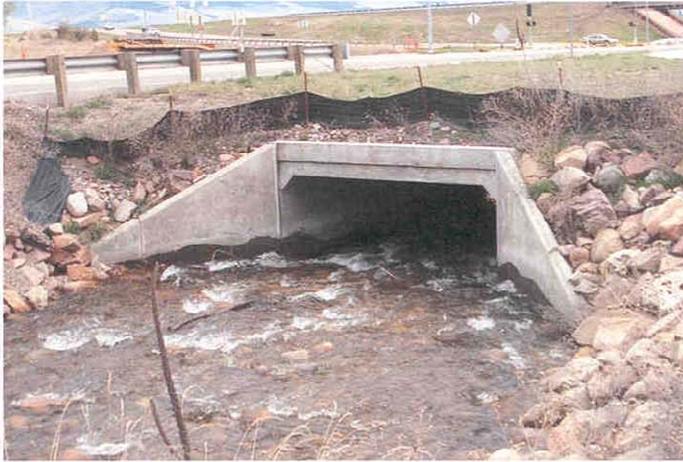
**#1**

**North end of  
800-foot long  
(14'x7') box culvert  
under I-90 and  
Reserve Street  
intersection**

My first concern is with the debris collecting on the bottom of the box culvert or being moved into the box culvert during high water. I doubt if anyone regularly inspects the interior of the culvert. Unlike most culverts, the irregular bottom is ideal for trapping debris. If a blockage took place during any significant event, no one could clear it by entering either end for fear of drowning. Flood flows would then crest and flow under I-90 and down Reserve Street. Grant Creek is rated at 245 CFS for a 10 year, 380 CFS for a 50 year, 465 CFS for a 100 year and 730 CFS for a 500 year storm event. These are significant flows and they will move accumulated debris downstream to the box culvert.

I would advise that serious consideration be given to clearing the floodway of accumulated debris, thinning brush, and thickets in the floodway and along Grant Creek Road to provide a safe and healthy riparian area and roadway. I also advise that the box culvert be inspected and a debris trap be constructed upstream of the box culvert.

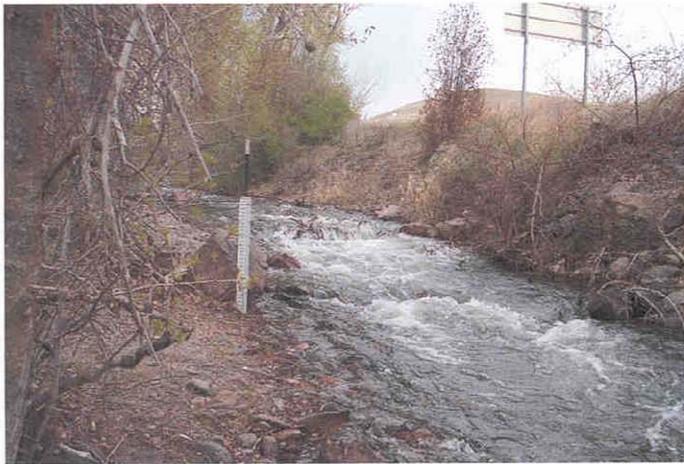
**#2**

**Stream gauging  
station between I-90  
and Expo Parkway**

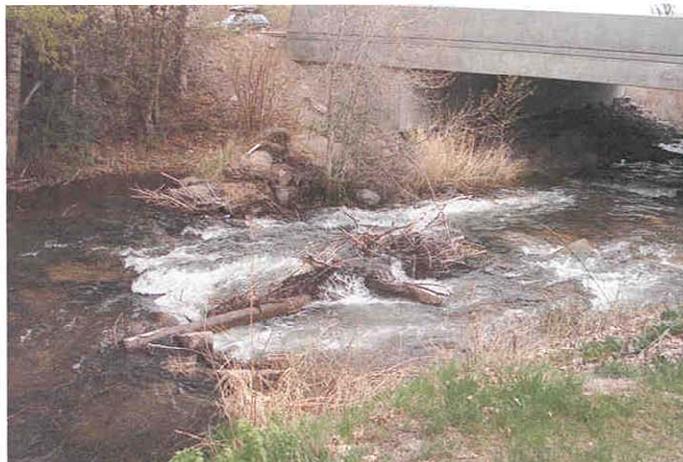
**#3**  
**Logs and debris  
upstream of Expo  
Parkway**

My second concern is with the upstream channel blockages by fallen trees and debris accumulation in the flood way. Trees that have fallen across and into the channel creating barbs that direct flows against the side of the channel and possibly the levee or Grant Creek Road. During a major event, the accumulated debris will collect on fallen trees creating dams that will raise the 100-year flood profile, placing adjacent property and improvements at risk. If water ever exited the west side of Grant Creek, it would not have a chance to get back into the channel before it discharged under I-90 and down Reserve Street.
