**CAPITAL IMPROVEMENT PROGRAM**  
**City of Missoula CIP Project Request Form FY 2017-2021**

<b>Program Category:</b>	<b>Project Title:</b>		<b>15 Project #</b>	<b>16 Project #</b>	<b>17 Project #</b>
Community Service	Grant Creek Drainage Improvements		CS-08	CS-05	CS-05

RE: Grant Creek Between I-90 and Prospect Drive

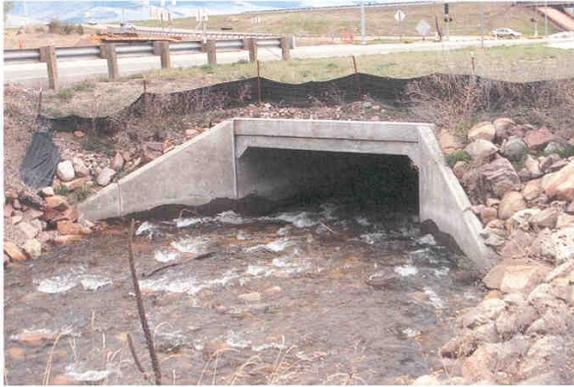
**#1**

My first concern is with the debris collecting on the bottom of the box culvert or being moved into the box culvert during high water. I doubt if anyone regularly inspects the interior of the culvert. Unlike most culverts, the irregular bottom is ideal for trapping debris. If a blockage took place during any significant event, no one could clear it by entering either end for fear of drowning. Flood flows would then crest and flow under I-90 and down Reserve Street. Grant Creek is rated at 245 CFS for a 10 year, 380 CFS for a 50 year, 465 CFS for a 100 year and 730 CFS for a 500 year storm event. These are significant flows and they will move accumulated debris downstream to the box culvert.

**North end of  
800-foot long  
(14'x7') box culvert  
under I-90 and  
Reserve Street  
intersection**

I would advise that serious consideration be given to clearing the floodway of accumulated debris, thinning brush, and thickets in the floodway and along Grant Creek Road to provide a safe and healthy riparian area and roadway. I also advise that the box culvert be inspected and a debris trap be constructed upstream of the box culvert.

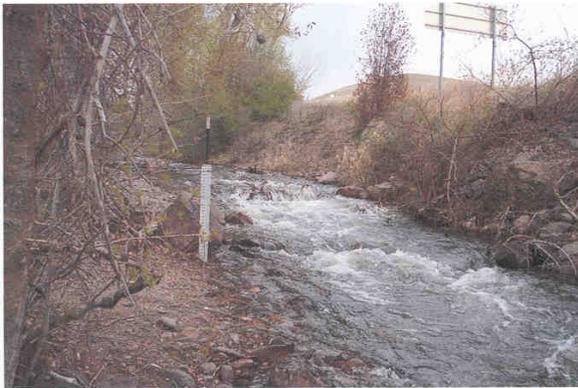
**#2**

**Stream gauging  
station between I-90  
and Expo Parkway**

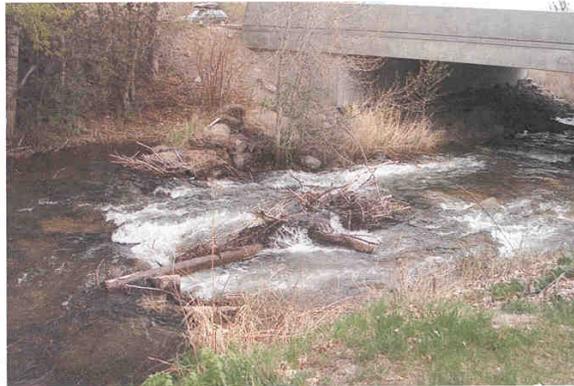
**#3**

My second concern is with the upstream channel blockages by fallen trees and debris accumulation in the flood way. Trees that have fallen across and into the channel creating barbs that direct flows against the side of the channel and possibly the levee or Grant Creek Road. During a major event, the accumulated debris will collect on fallen trees creating dams that will raise the 100-year flood profile, placing adjacent property and improvements at risk. If water ever exited the west side of Grant Creek, it would not have a chance to get back into the channel before it discharged under I-90 and down Reserve Street.

**Logs and debris  
upstream of Expo  
Parkway**
